CHARACTERIZATION AND ANALYSIS OF PREHISTORIC EARTHEN PLASTERS, MORTARS, AND PAINTS FROM MUG HOUSE, MESA VERDE NATIONAL PARK COLORADO

Linnaea A. Dix

A THESIS

1996

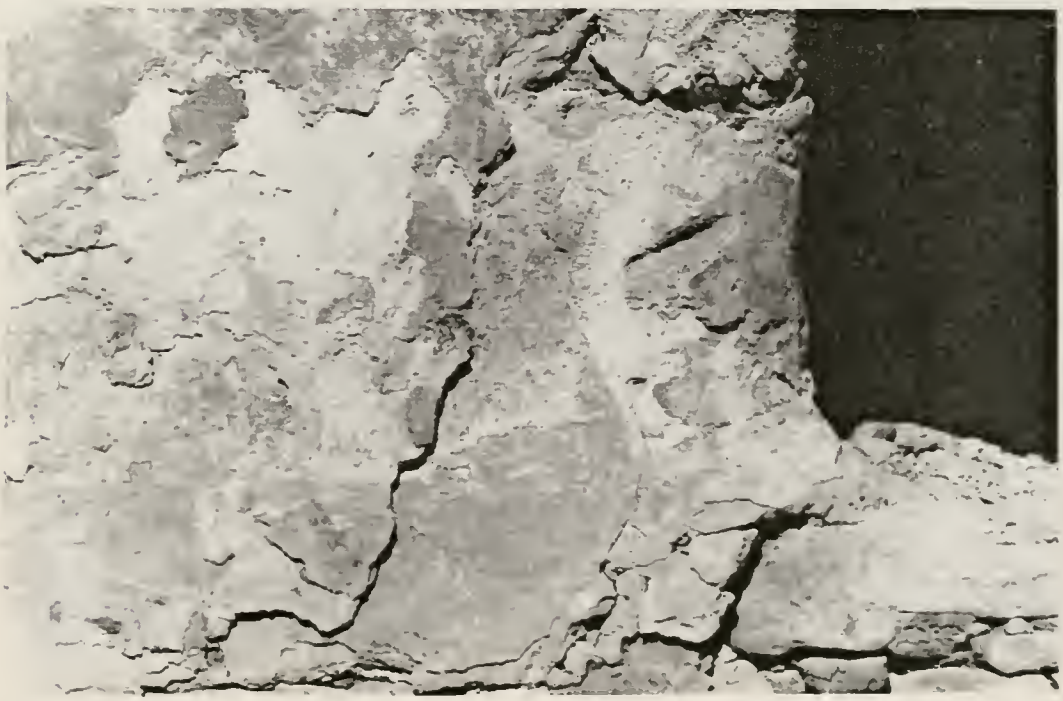
Fig. 20 Detail of Kiva C Plaster — Note Triangle Design in Center of Photograph

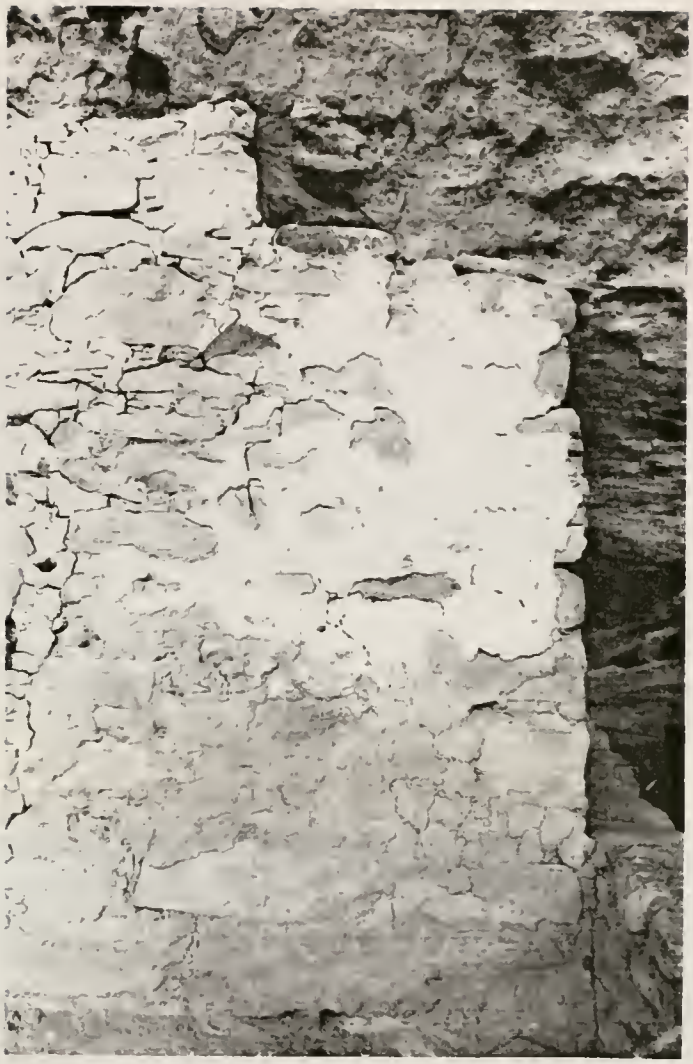
Fig. 26 Detail of Room 28 Plaster
